Vibration monitoring of Bonn Center demolition with MR3000C and MR3000BLA

Abstract

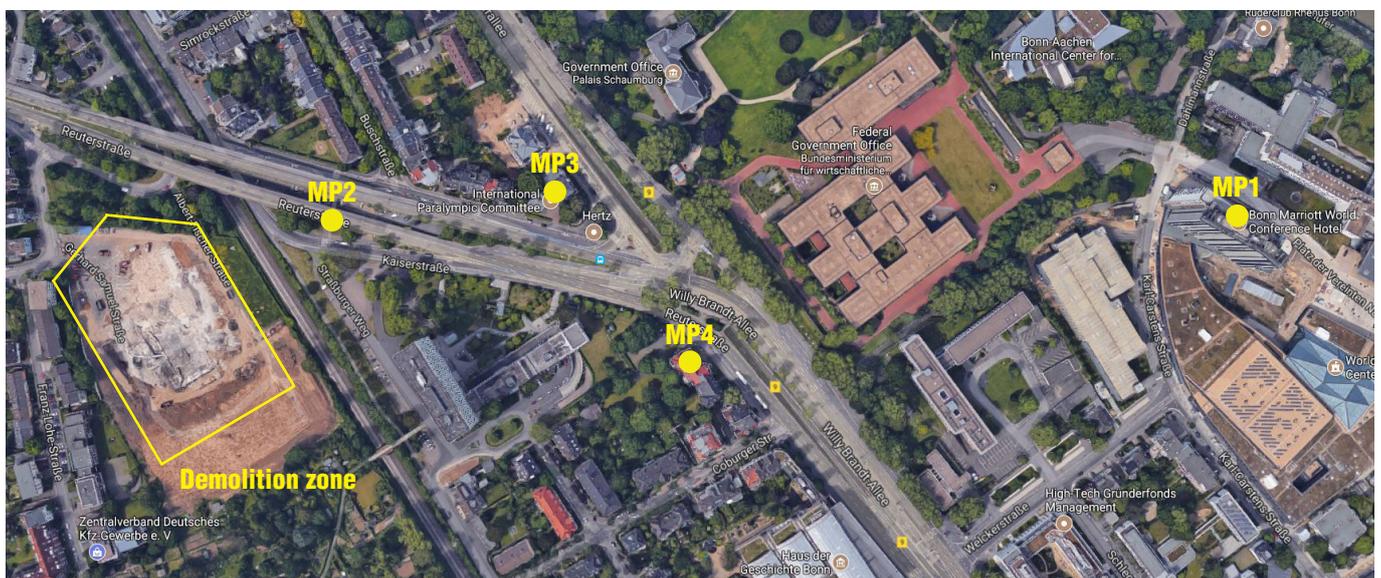
Figure 2. Map with the demolition zone and the measurement points.

The vibration monitoring is done on 4 different points close to the demolition zone, according to the map in Figure 2. The instruments in the different locations are shown in Figure 3, while the devices used and the distances from the demolition zone are listed in Table 1.

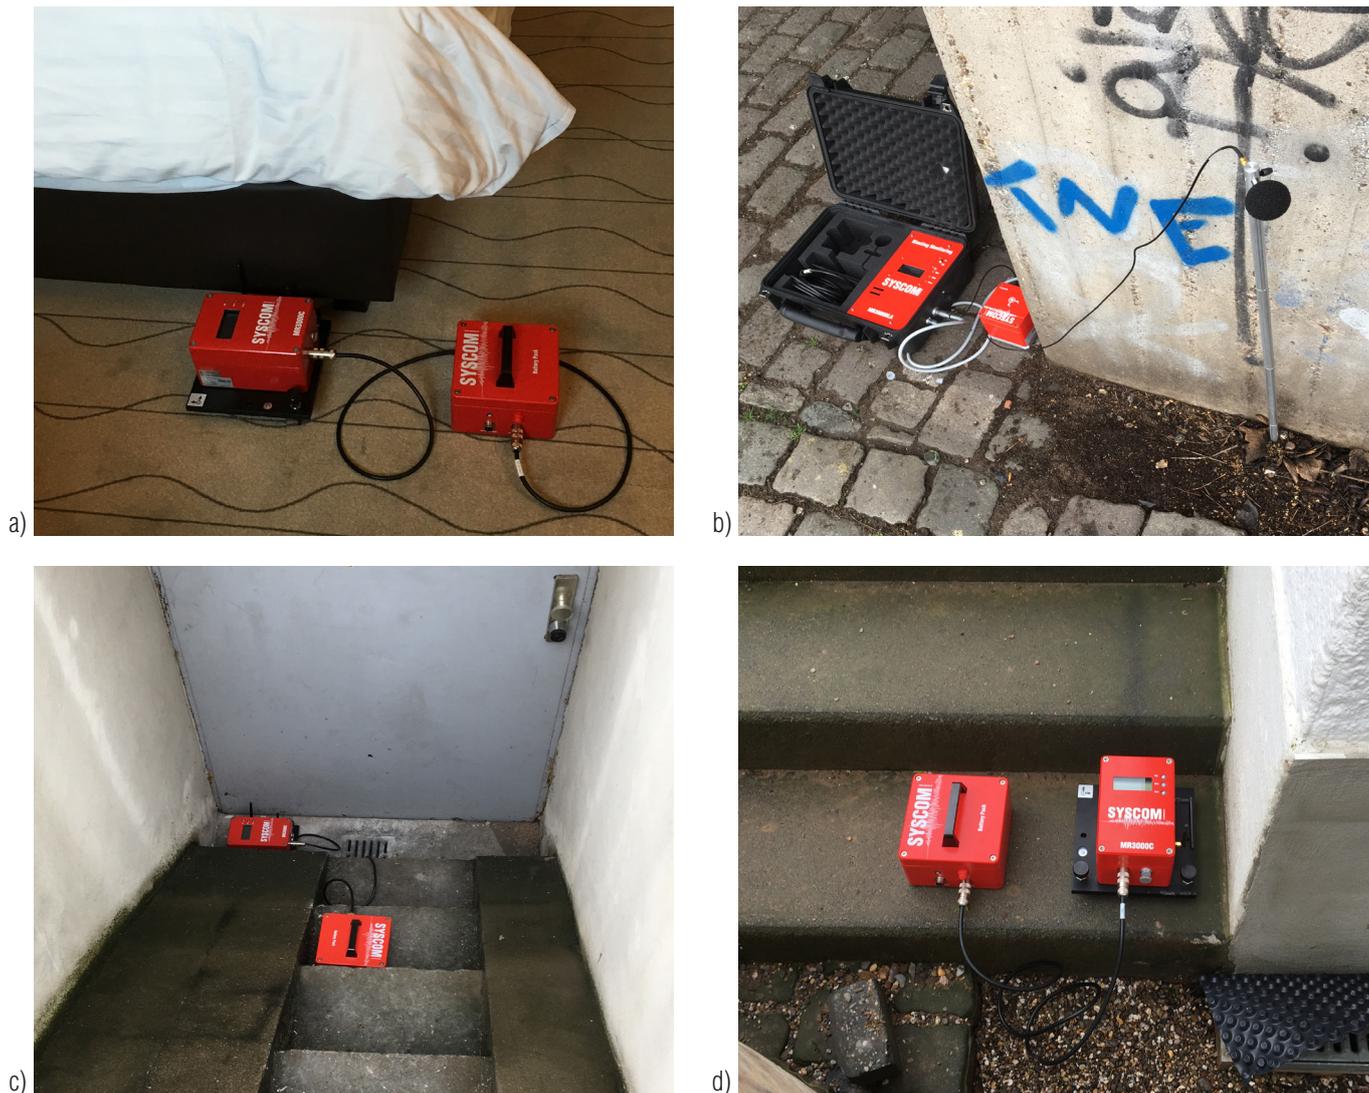
Figure 3. Instruments installed for the vibration monitoring: MR3000C in MP1 (a); MR3000BLA in MP2 (b), MR3000C in MP3 (c) and MR3000C in MP4 (d).

Three MR3000C and one MR3000BLA are used for the vibration monitoring. The MR3000BLA is installed in the point closest to the demolition site, to measure also the air pressure. The microphone is oriented in the direction of the explosion.

The MR3000C in MP1 is installed in a room inside the Bonn Marriott Conference Hotel, while the instruments in the other locations are installed close to the foundations of each building, in order to measure the vibrations transmitted from the ground to the structures. For this reason, the values recorded are compared to the limits defined by the German standard DIN 4150-3, concerning vibrations at foundation for residential buildings.

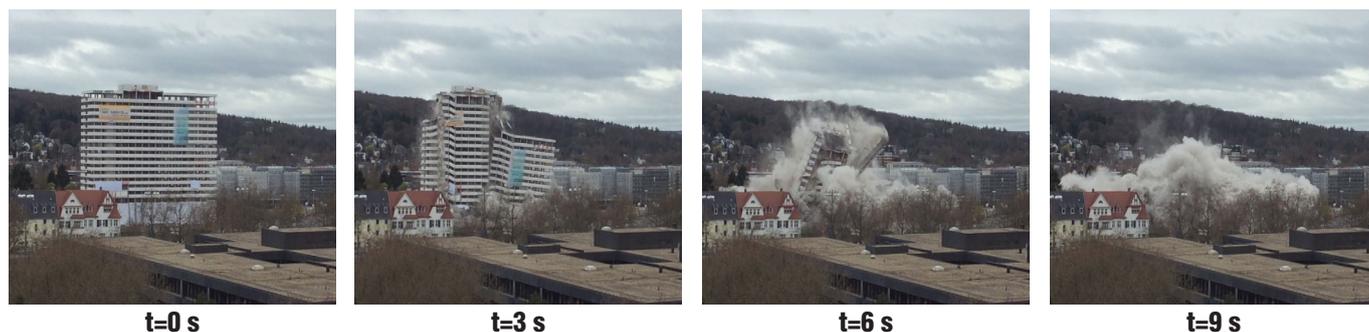
Figure 4. Successive instants of the Bonn Center demolition, seen from the Bonn Marriott Conference Hotel.

In Figure 4, successive time instants related to the demolition of the Bonn center are represented. They are taken from the Bonn Marriott Conference Hotel.

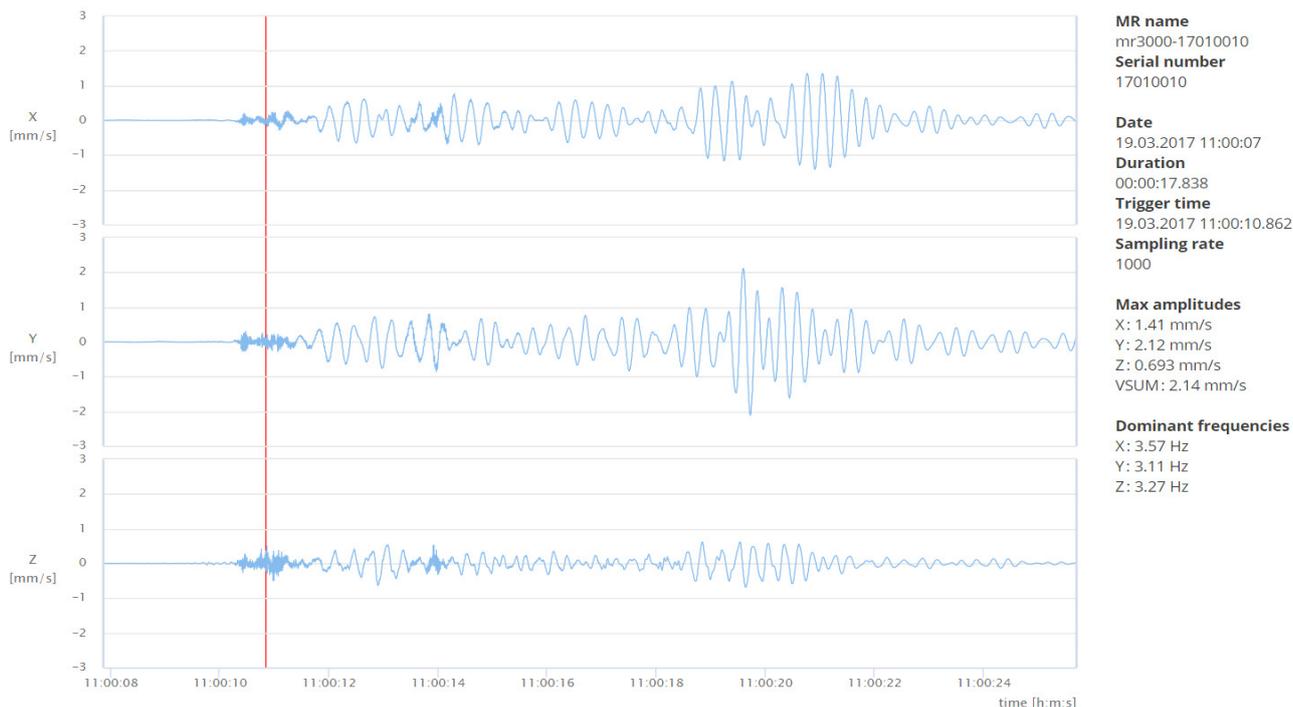
Figure 5. Time histories recorded in MP1, in the Bonn Marriott Conference Hotel, during the demolition of the Bonn Center.

The analysis of the data is done with the SCS cloud software. In Figure 5, the time histories recorded in MP1 are displayed. The Bonn Marriott Conference Hotel shows significant vibrations for a duration of about 12 seconds.
