Monitoring of **controlled demolition, Sesto San Giovanni, Italy**

Case study

July 2022

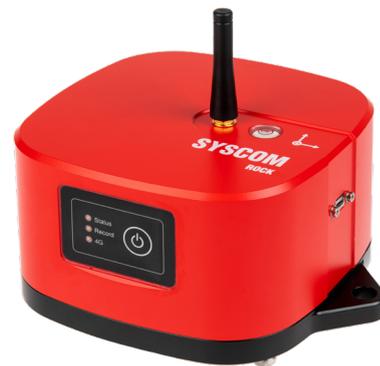
ROCK autonomous vibration monitoring device

The benefit of using the Syscom ROCK is having an entirely cable free device, very quickly installed at relevant locations on site and its unrivalled ease of use. A unique ON/OFF button enables the device to start monitoring all site vibration. The data are automatically transferred then to the Syscom Cloud Software (SCS) without any additional configuration, like SIM cards or APN networks (Access Point Network) setup.

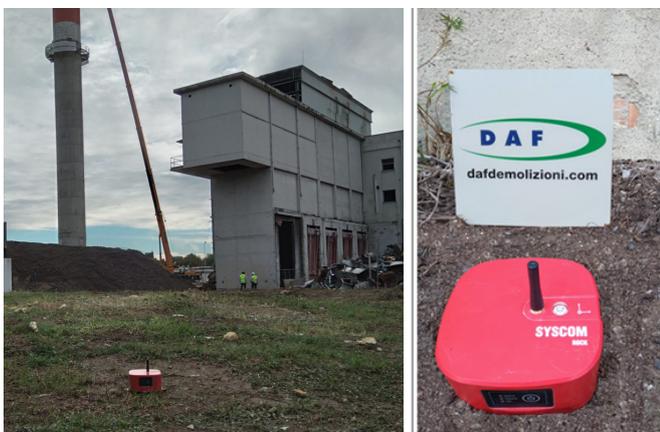
Figure 1: Setup of the ROCK device on location.

The monitoring unit was located along the north/west perimeter of the construction site, at the base of the perimeter wall, bordering the production building closest to the fall area, to analyse the vibratory effects due to the planned collapse of the chimney.

In Figure 1, the ROCK is partially buried for a proper ground to internal sensor coupling. This is very relevant when mid to high frequencies are expected with significant PPV amplitudes.

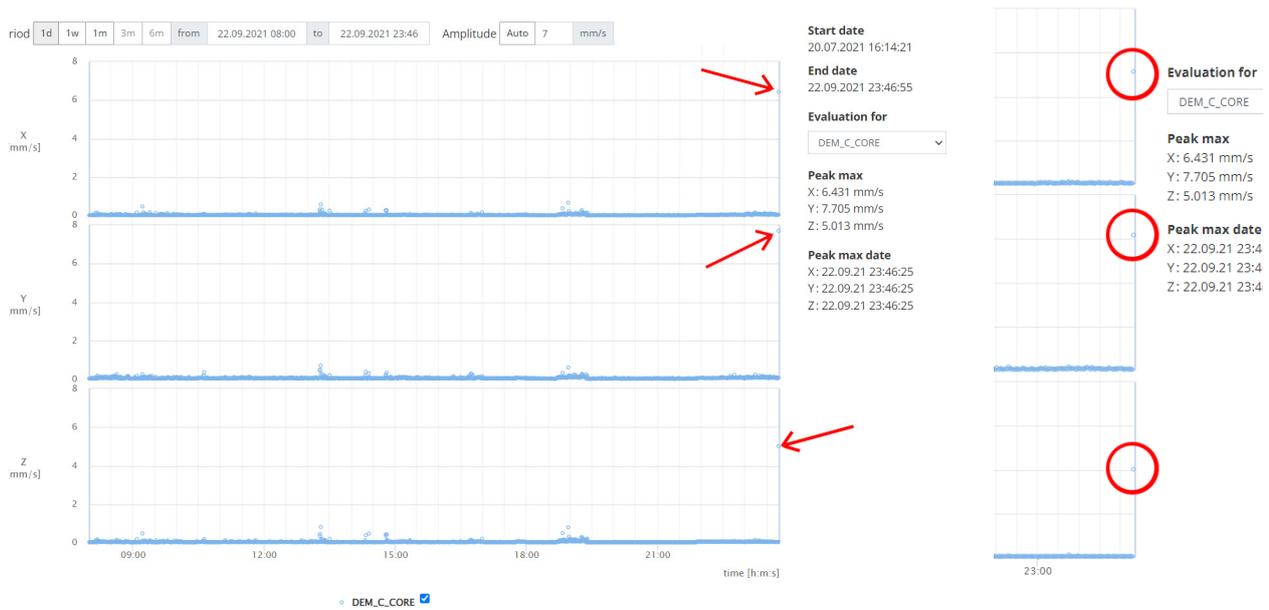
Figure 2: Background monitoring of the whole monitoring period. On the right: zoom on the demolition period with highlight on the event shown in Figure 3 (time history) and in Figure 4 (comparison with the norm).

All vibrations are below the trigger level threshold of 1 mm/s for all three axis (X, Y, Z) configured in the ROCK device, except for the collapse. This is shown in Figure 2. The complete collapse of the chimney at 23h46 and the demolition activities are visible, starting at around 22h, with higher ambient vibration recorded.

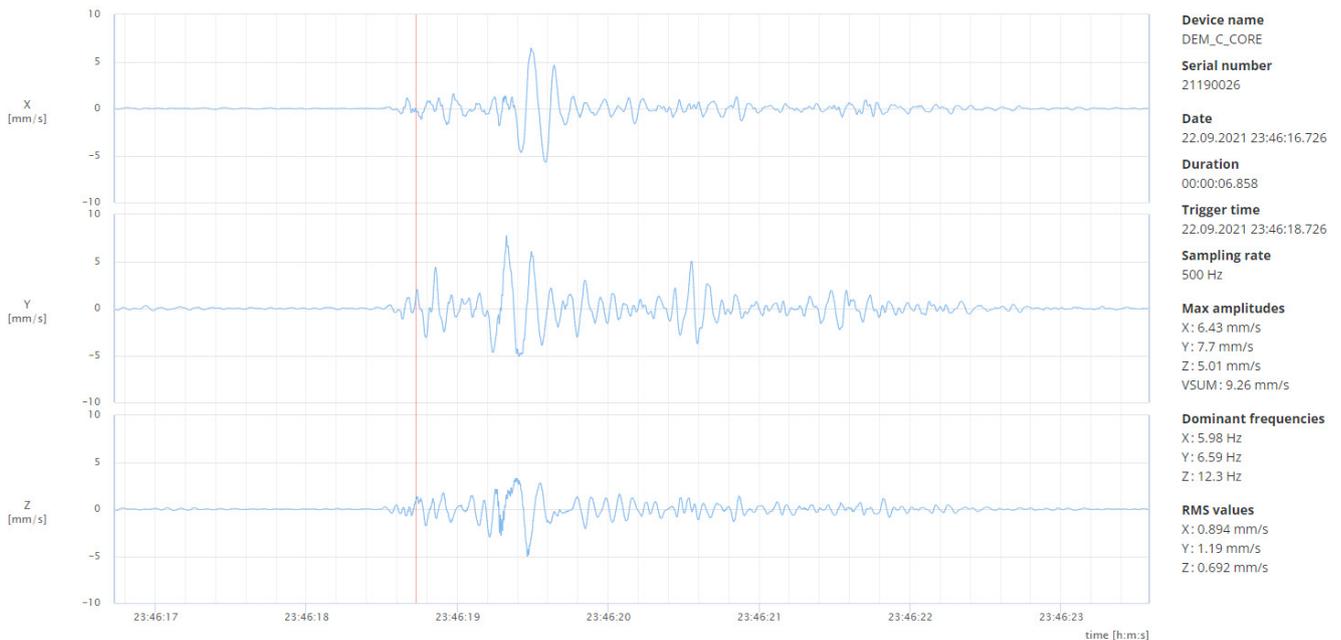
Figure 3: Event generated by the tower collapsing and hitting the ground. Horizontal XY and vertical Z traces recorded by the ROCK.

During the demolition, two events were recorded (one of them is shown in Figure 3). They were generated by the impact of the chimney on the ground. Events are sent automatically to the SCS cloud software and a PDF report is sent by email within one minute after the event to all relevant project stakeholders. Both events were below the threshold of the reference limits of the DIN 4150-3 standard, as shown in Figure 4.

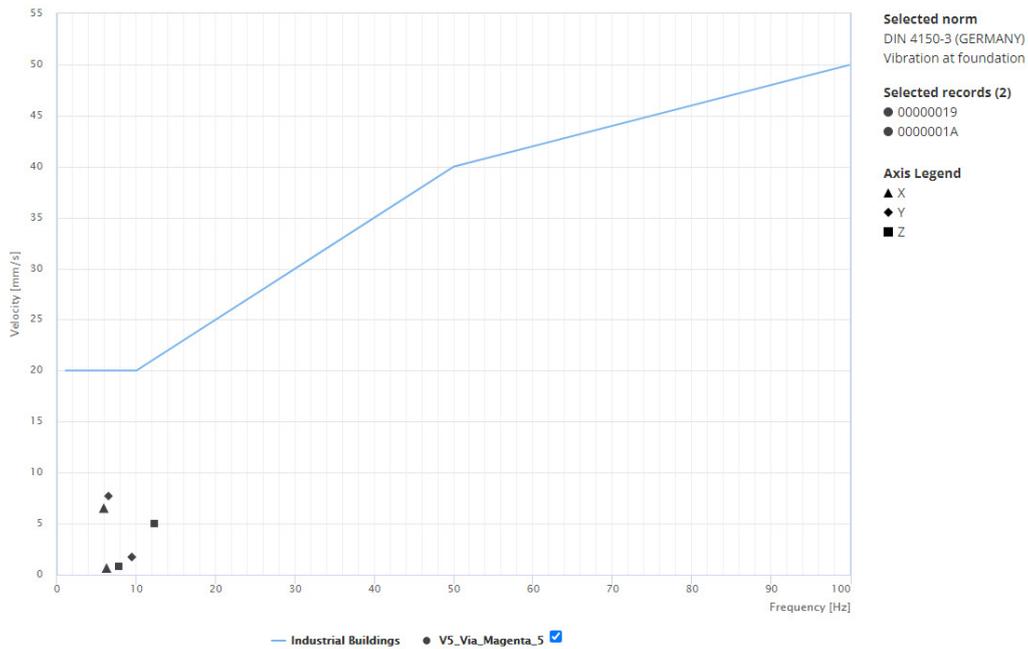
Figure 4: Comparison of the two events recorded values with the DIN 4150-3 limits for industrial buildings, vibration at foundation.

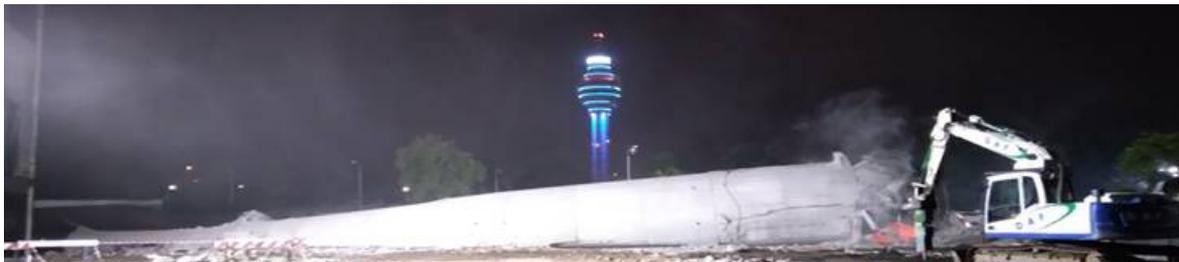
Figure 5: Controlled collapse of the chimney.

The measuring period is from 8h00 to 24h00 on September 22, 2021. The demolition activities started the same day at 22h00 and lasted up to 23h46, time of the collapse
