Vibration monitoring, Retzstadt, Germany

Case study

Vibration monitoring during the renovation of a residential building

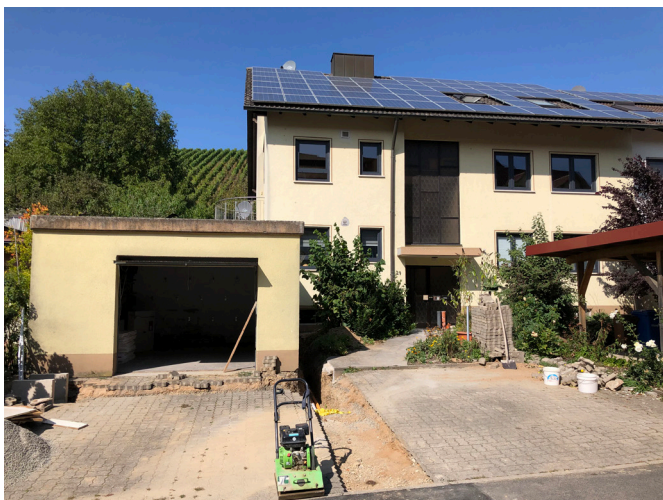
Figure 2: Exterior view of the residential building

The location of Retzstadt on the map of Germany is indicated in Figure 1, while the residential building is shown in Figure 2.

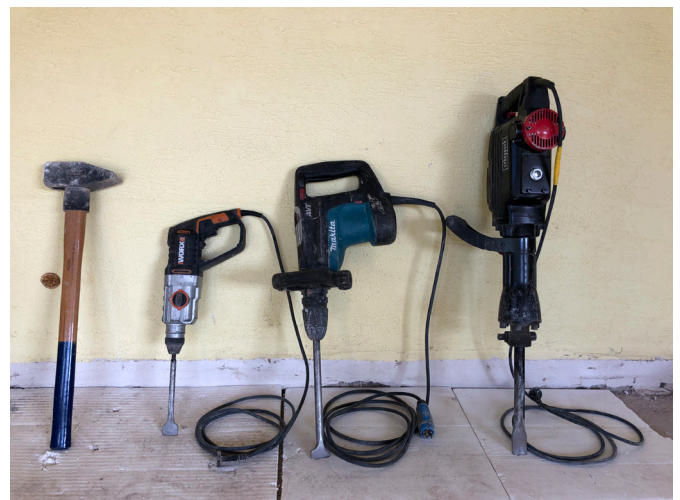
Figure 3: Tools used for the works.

The demolition is mainly carried out with the tools and machines indicated in Table 1 and shown in Figure 3.

Table 1. Technical characteristics of the tools used.

Tool	Technical characteristics
Sledge hammer	4 Kg
Demolition hammer	800 W / 2.5 J
Demolition hammer	1350 W / 9.4 J
Demolition hammer	1700 W / 50 J

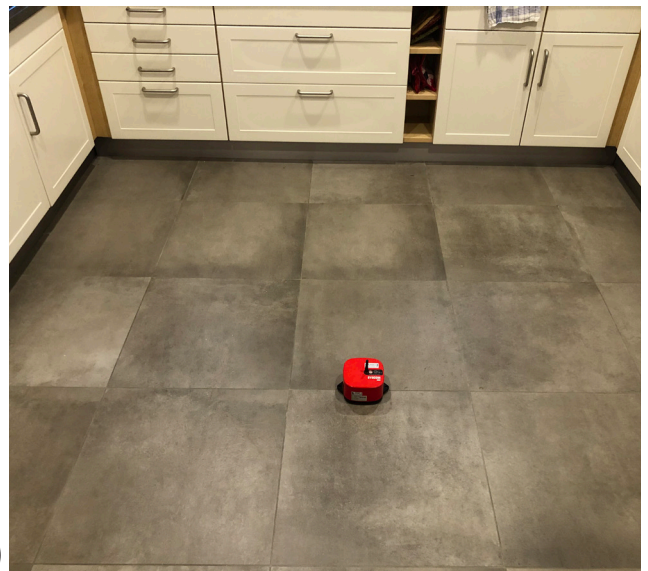
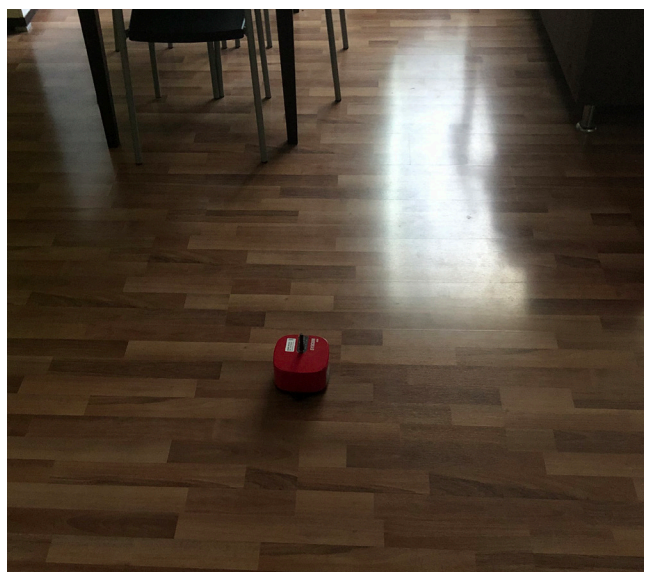
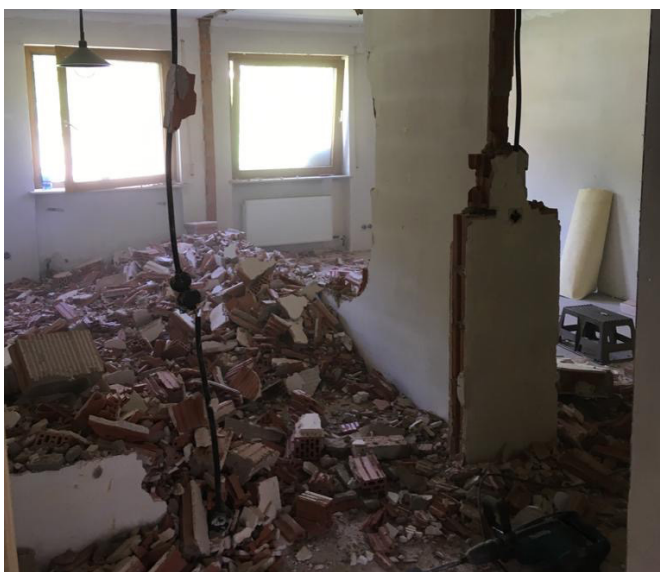
Figure 5. Devices installed for the project: a) MP1 in the cellar; b) MP2 in the kitchen of the ground floor; c) MP3 in the living room on the top floor.

The monitoring is carried out at three measuring points:

- MP1: Cellar/foundation
- MP2: Ground floor kitchen
- MP3: Top floor living room

The instruments are shown in Figure 5, while their configuration is indicated in Table 2.

Table 2. Parameters used inside the ROCK devices.

Parameter	Value
Sampling frequency	1000 Hz
Frequency range	1 - 315 Hz (DIN 45669-1)
Trigger level	0.5 mm/s on the three axes
Reference norm	DIN 4150-3, curve related to residential buildings
Alarm 1	75% of the reference norm
Alarm 2	100% of the reference norm

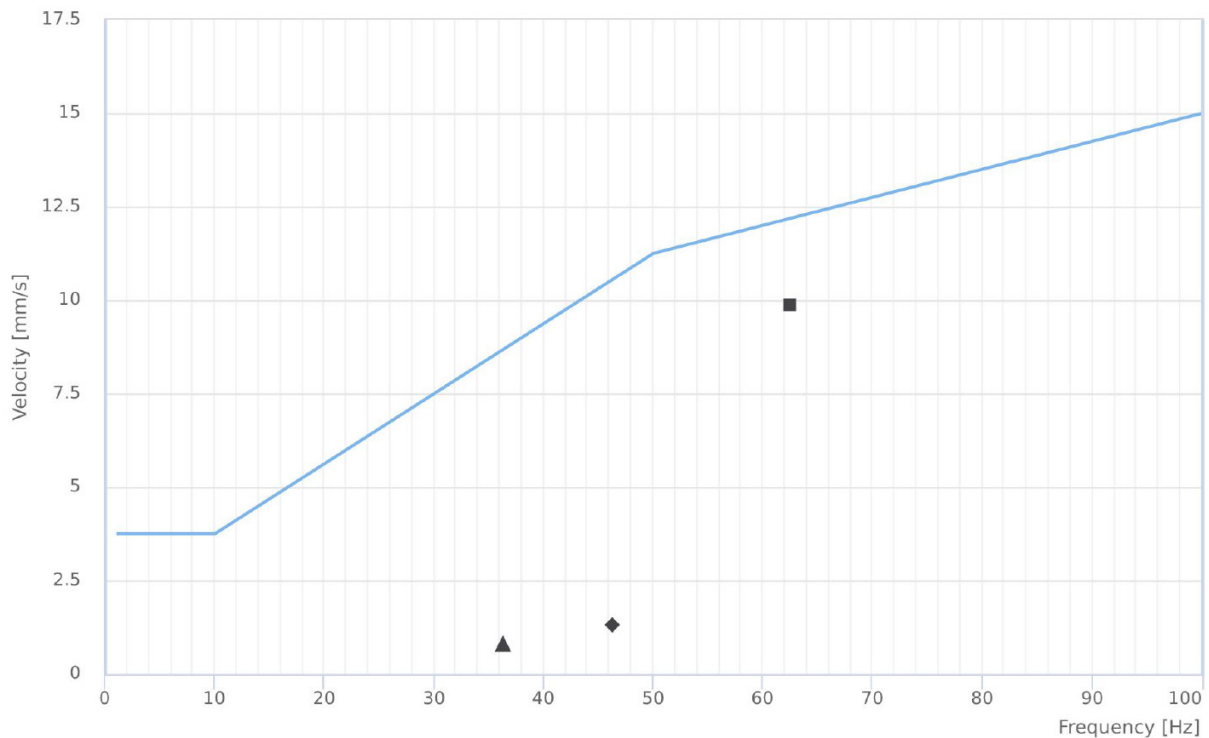
Figure 6. Comparison with the German norm DIN 4150-3, for residential buildings, for an event recorded at the measurement point MP2.

The evaluation of the recorded data is carried out by the SCS (Syscom Cloud Software - scs.syscom-instruments.com). When the trigger threshold is exceeded, the data are automatically recorded and transferred to the SCS, and then compared with the DIN 4150-3 (residential buildings).

Despite quite high amplitude vibrations in the whole house, the threshold values of DIN 4150-3 were not exceeded. Referring to figure 6, an event with significant vibrations recorded at MP2 is compared with the reference norm.
