Vibration monitoring, Zürich Train Station, Switzerland

Case study

Vibration monitoring of train station and surrounding buildings in Zürich using SYSCOM MR3000C instruments

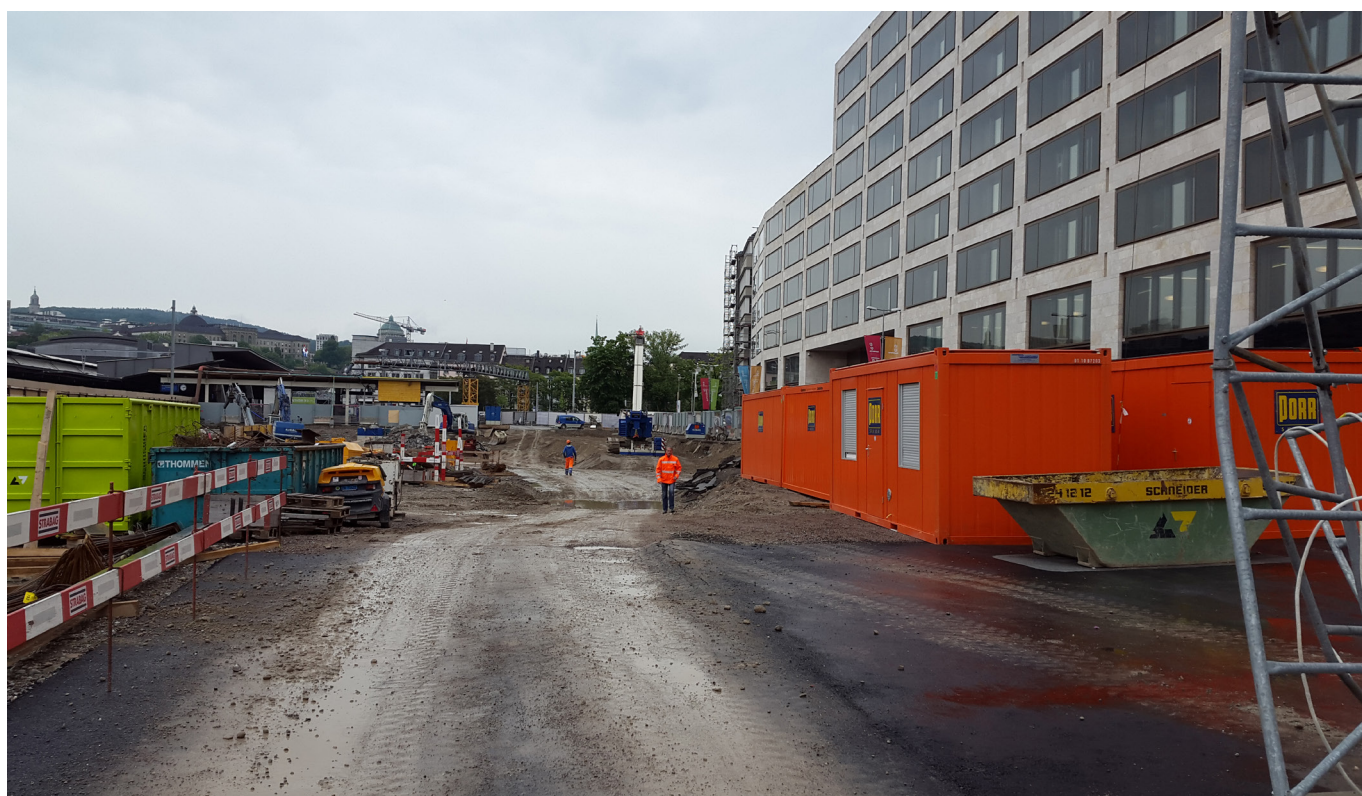
Figure 1. The construction site, with the train station on the left and the buildings on the right.

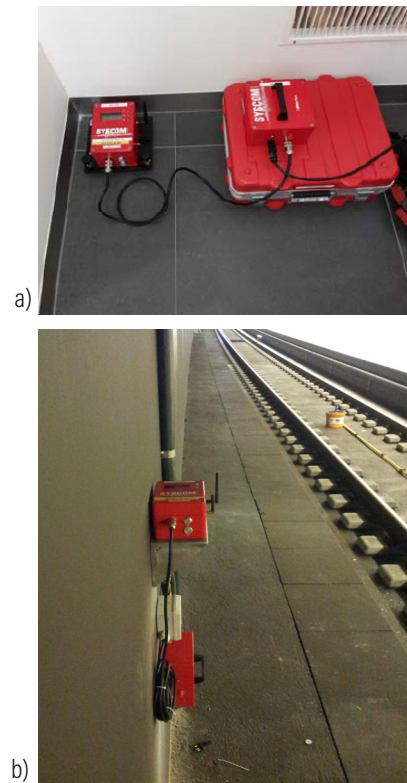
Figure 3. MR3000C in MP1 (a) and MP4 (b).

The MR3000C in the measuring points MP1, MP2 and MP3 are located inside different buildings while the MR3000C in position MP4 has been installed in the new underground train station, next to track 31 (see Figure 3).

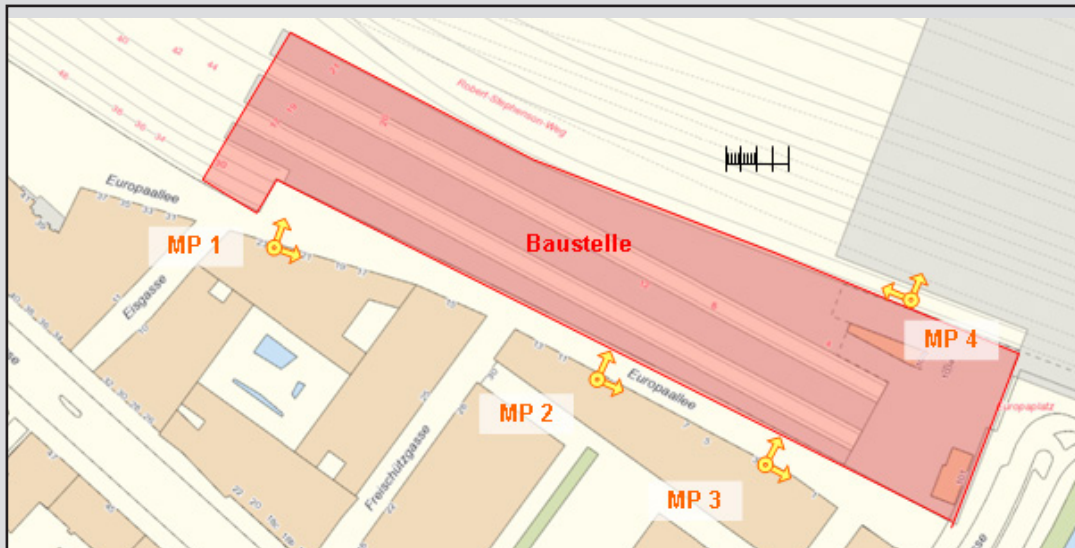
Figure 2. Overview of the monitoring project.

NOTE: The red zone delimits the construction works between the train station and the buildings on Europaallee.

MP	Location	Trigger	Alarm 1	Alarm 2
MP1	Europaallee 23	0.5 mm/s	2 mm/s	4 mm/s
MP2	Europaallee 11	0.5 mm/s	2 mm/s	4 mm/s
MP3	Europaallee 3	0.5 mm/s	2 mm/s	4 mm/s
MP4	Train station, platform 31	1.0 mm/s	2 mm/s	4 mm/s

The site map is displayed in Figure 2. The four measurement points MP1-MP4 have been equipped with a MR3000C with:

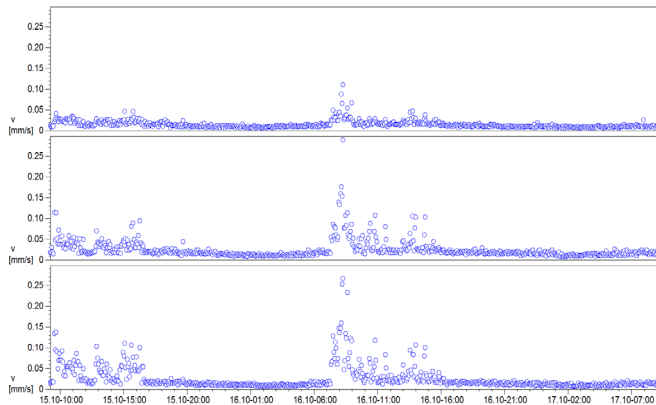
Figure 4. Background values recorded at MP1 between October 15th and 17th, displayed with EAW Light.

In Figure 4, the background values recorded at MP1 during two days in October 2015 shows the different vibration levels between day and night. The vibration are higher between 7:00 and 12:00 and from 13:00 to 16:00, corresponding to the working time period on site.

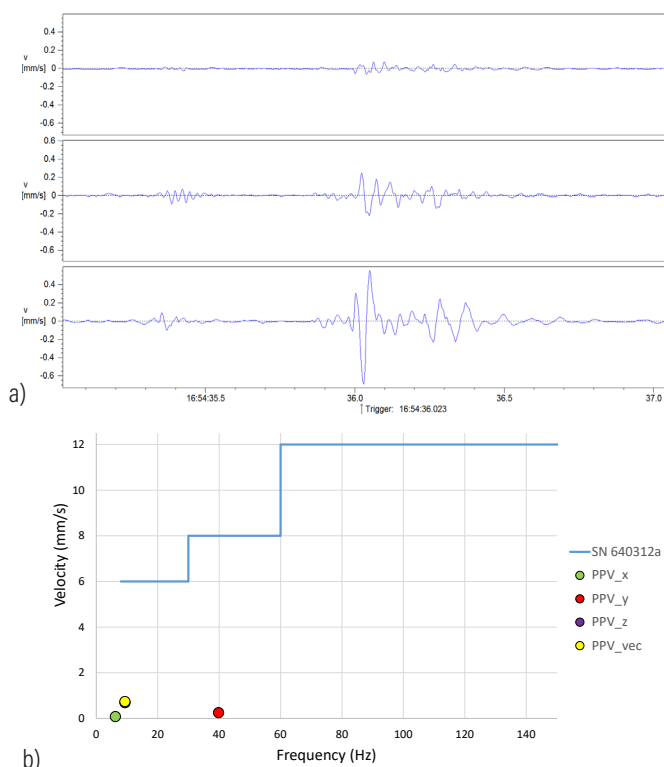
Figure 5. Event recorded in October 2015 on MP1: Time histories (a) and comparison with the Swiss norm SN 640312a (b).

In Figure 5, the most critical event recorded at MP1 during October 2015 is shown. For each event, the maximum velocity and frequency for the three axes and the vector (module of the three components) are saved. These values are called PPV (Peak Particle Velocity). As in most cases, the vertical component (z-axis) is the predominant one.

The PPVs of the event are then compared with the limits defined by the Swiss regulation SN 640312a. In particular, the values are compared with the curve for "sensitive buildings" and "frequent vibration", since the monitoring is performed on commercial buildings and the works are realized every day from Monday to Friday.

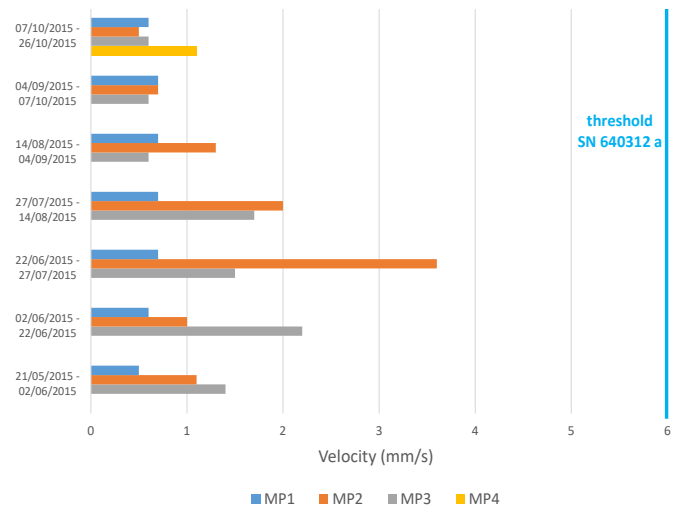
Figure 6. Maximum vibration values from May 2015 to October 2015.

In Figure 6, the maximum values saved in different periods between May 2015 and October 2015 are displayed. MP4 has been installed only at the beginning of October. Up to now, the vibration levels never reached 6 mm/s, critical threshold defined by the Swiss norm for the low frequencies.
